### SERVICE INSTRUCTION

**Number:** 381-1933

### SID message "TIME FOR SERVICE"

All Saab 9-5

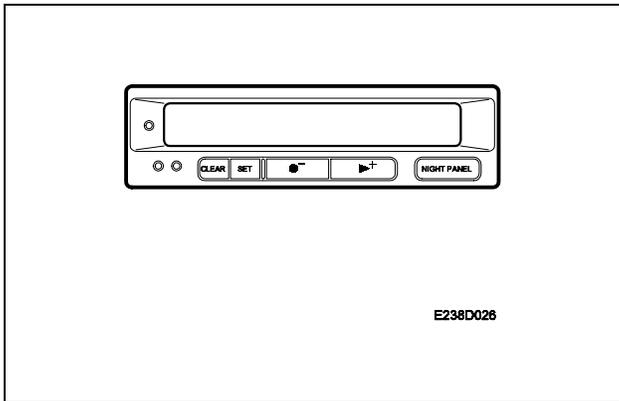
The new software in the SID requires a different procedure to cancel the "TIME FOR SERVICE" message with the CLEAR button on the SID.

To reset the "TIME FOR SERVICE" message on the SID (without using Tech 2), the following procedure must be followed:

- 1 Press the CLEAR button once.
- 2 Press the CLEAR button a second time and hold it pressed in for at least 8 seconds.  
The SID will give two acoustic signals one shortly after the other. On the second signal the message "SERVICE" will start to flash.
- 3 Start the engine to make sure that the message has been cancelled.
